Smoke and Dye Testing Summary

High Level Sewershed

Test ID	Test Type	Date Inspected	Company / Super.	Blower MH	Ground Condition	Notification Made?	Total Length
S1028-229	Smoke	8/11/2009	ADS/TM	S21MM_008MH	Dry	Yes	753.88

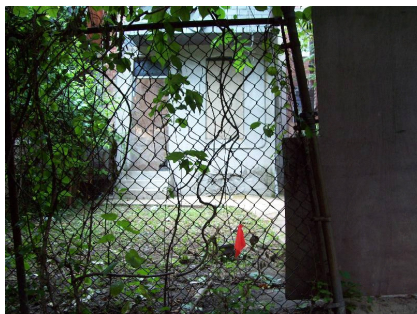
Picture \S1028-229-OB01-P01.jpg

Comments Smoke from cleanout in back yard. 2207 Lynnbrook Ave.

Comments Back of house, 2207 Lynnbrook Ave.

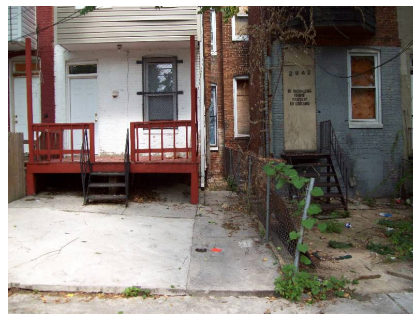
Picture \S1028-229-OB02-P01.jpg

Comments Smoke from cleanout in back yard. 2844 Woodbrook Ave.

Comments Back of house, 2844 Woodbrook Ave.

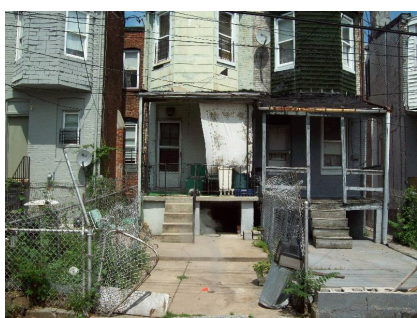
Picture \S1028-229-OB03-P01.jpg

Comments Smoke from cleanout in back yard in paved concrete. 2818 Woodbrook Ave.

Comments Back of house, 2818 Woodbrook Ave.
